Essex Junction Recreation and Parks Ash Tree Inventory

Malcolm Richardson, Thor Belle, Karla Noboa and Suzanne Trammel

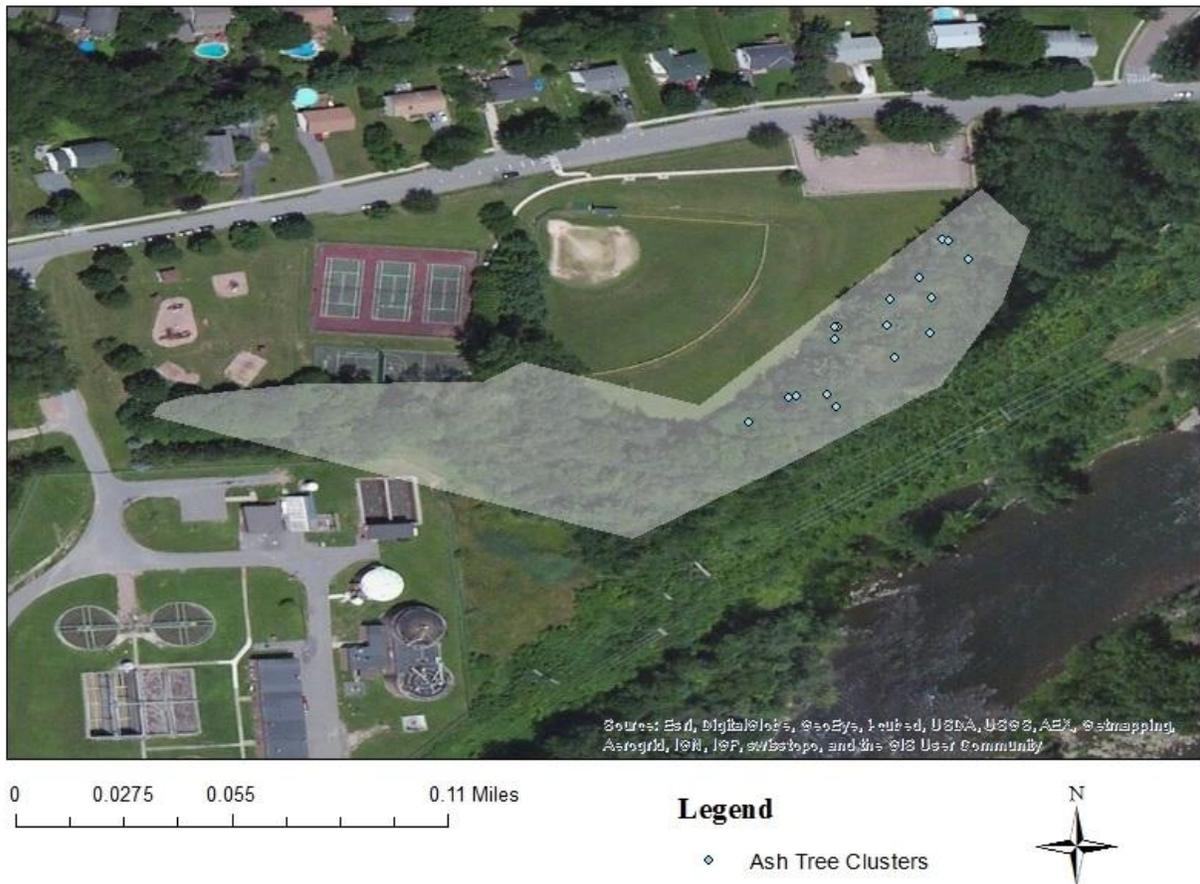
Figure 3. A map of the ash tree clusters on the eastern side of Cascade Park.

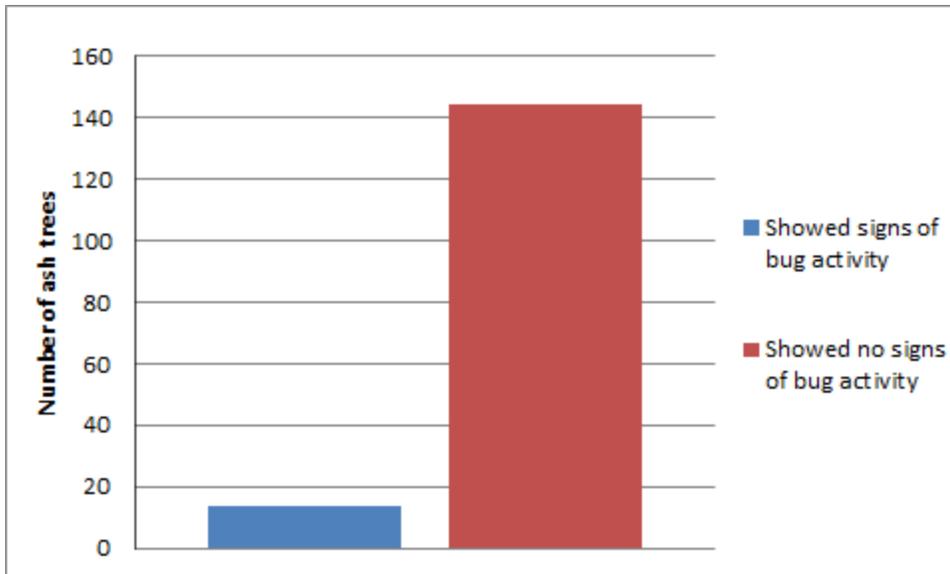
At Cascade Park, there was approximately 158 ash trees. At closer investigation, almost 20 trees exhibiting signs of EAB infestation were found. Many of these had D-Shaped exit holes and a few had s-shaped galleries beneath the bark. Approximately 9% of the trees in the park had potential infestations and should be further inspected.

Figure 4. Total number of ash trees showing signs of bug activity at Cascade Park in Essex Junction.

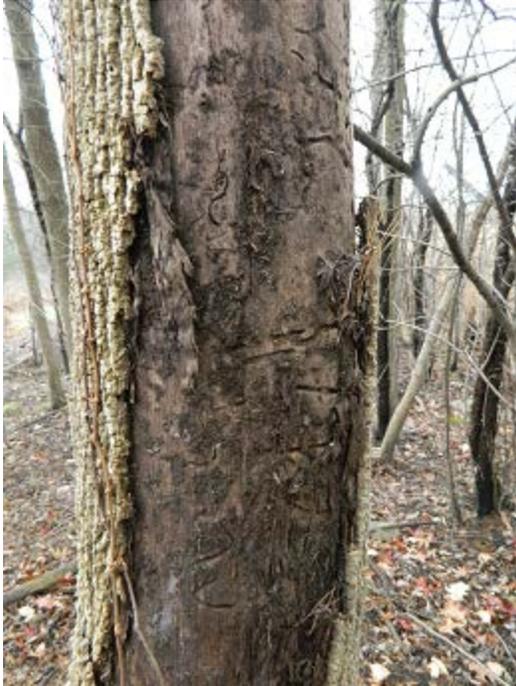
Image 1. S-shaped galleries

At Cascade Park, there is a large possibility of EAB infestation. Approximately 9% of the trees exhibited signs and symptoms of EAB, like exit holes and epicormic shoots. A closer investigation of these trees is necessary and a professional inspection to confirm or deny the presence of this invasive insect is crucial. As far as continuing to survey for EAB, a monthly inspection of the flagged trees should be conducted to monitor for further damage. It is also suggested that the trees currently cut down on the property should not be moved from the area and trees exhibiting signs and symptoms should not be removed from the property.

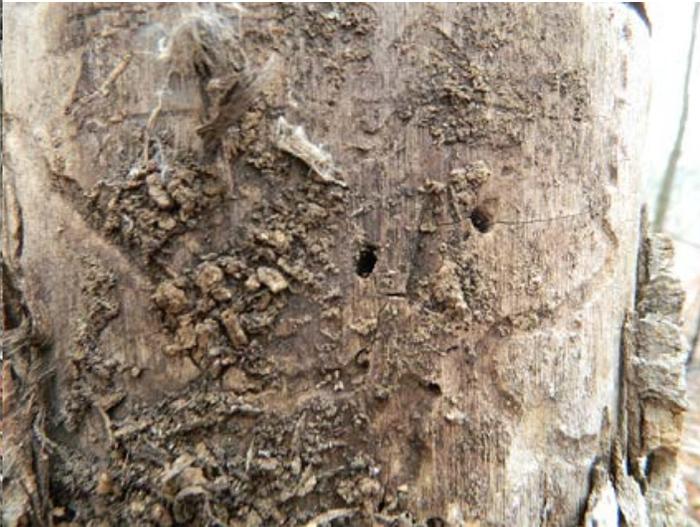
It is possible that Emerald Ash Borer has reached Cascade Park. Multiple ash trees were cut down along the paths at the park, which signaled at movement of wood in the area. The movement of wood from one location to another is the main cause for the spread of EAB. Many of the ash trees at Cascade Park exhibited signs and symptoms of the insect and the abundance of D-shaped exit holes are a cause for concern.

Image 2. D-Shaped exit holes and frass filled galleries
