# Tree health and mechanical damage

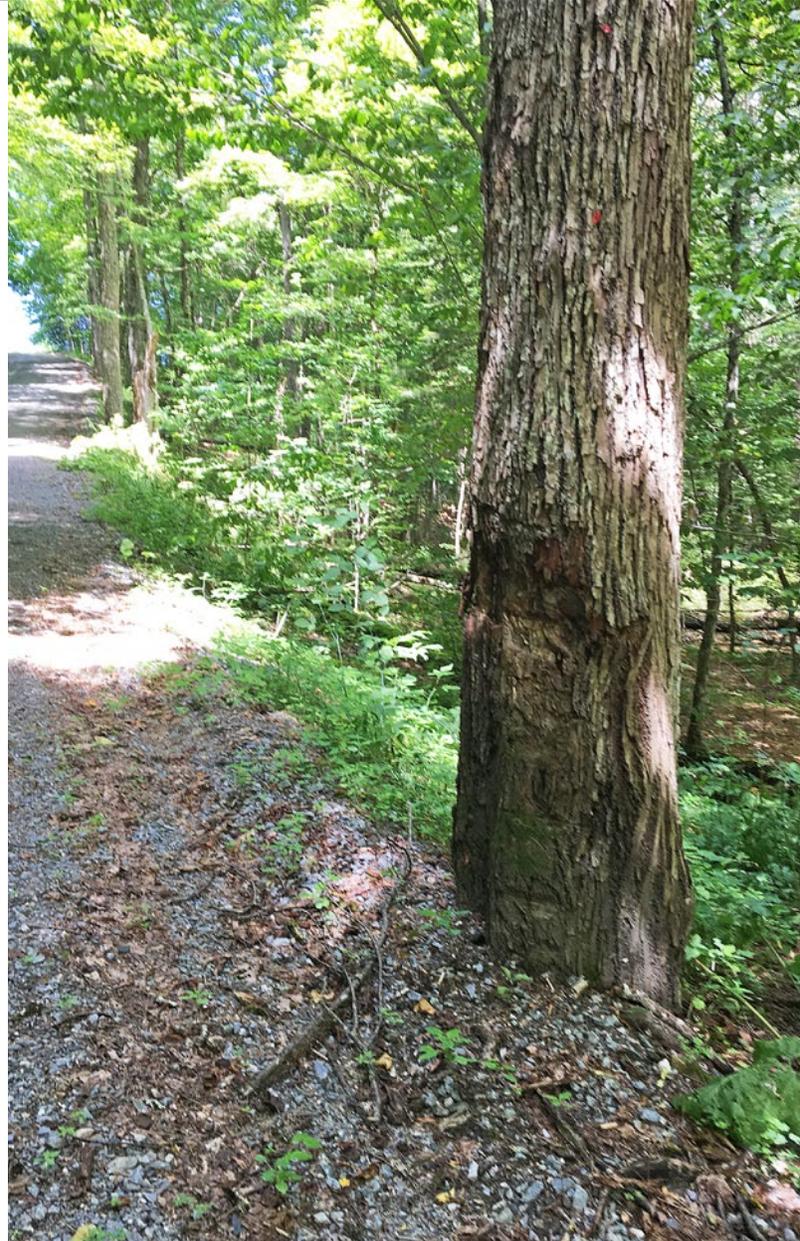
*Repeated impacts from vehicles or machinery have damaged this roadside tree.*

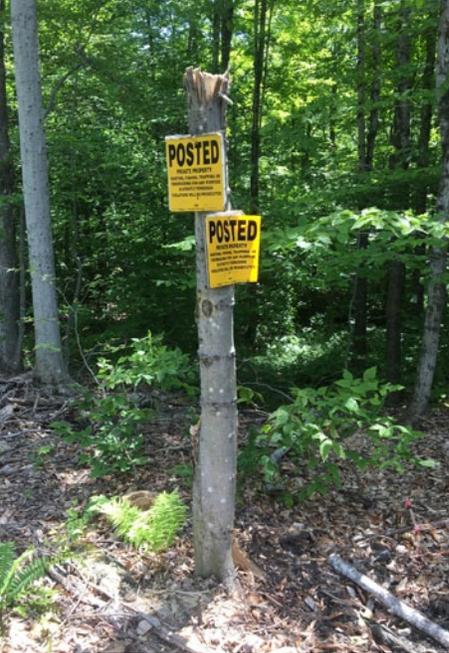
**ABOVE** Although standing dead trunks create wildlife habitat, they also pose risk for road users. Trees removed from the right-of-way should be cut to less than four inches in height to eliminate damage to vehicles pulled off the road.

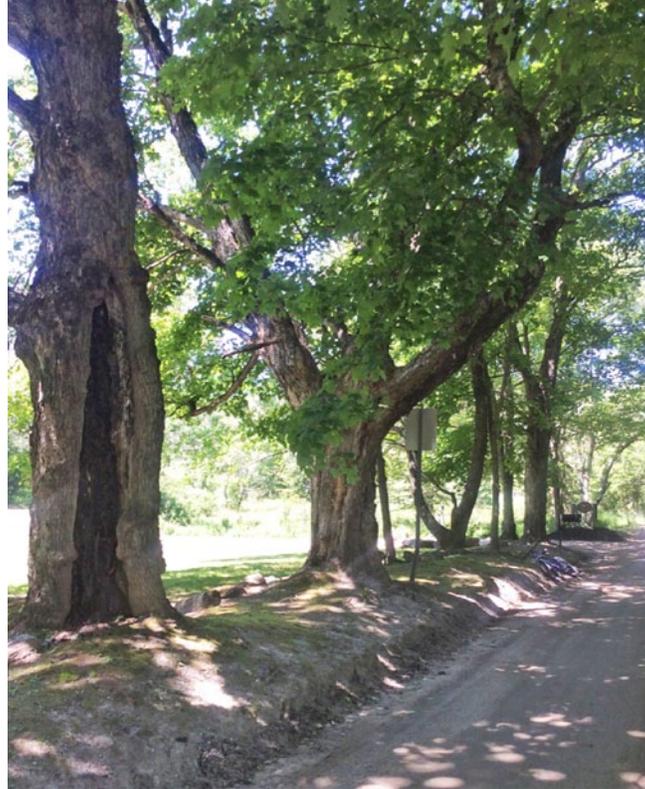
**CENTER** Damaged mature trees line a sunken roadbed that prevents stormwater sheet flow runoff. Reduce mowing beneath mature trees, plant shade-tolerant wildflowers or grasses, plant seedlings between mature trees to establish the next generation of roadside canopy, construct stone turnouts to direct water away from the road, or raise the roadbed to allow for sheet flow to either side of the road.

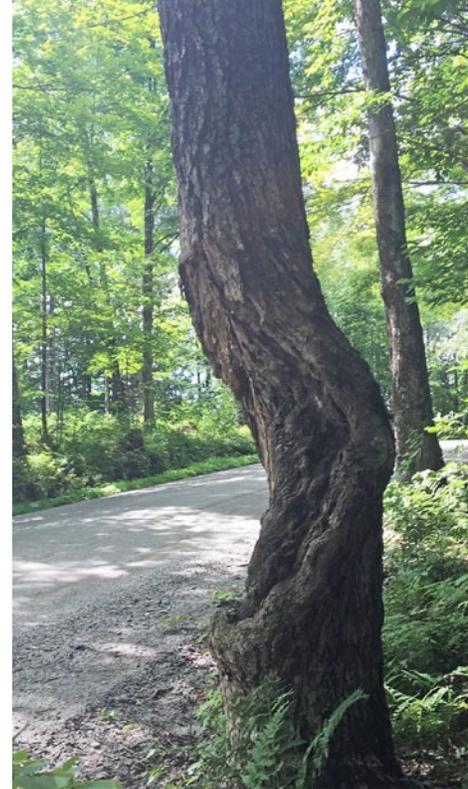
**FAR RIGHT** A canker weakens a roadside tree, creating risk for road users, particularly if the tree is hit by a vehicle or road machinery.
